BEAR ROCK NO.1 DAM

NDI I.D. NO: PA-00439

PHASE I INSPECTION REPORT
NATIONAL DAM INSPECTION PROGRAM

NAME OF DAM: Bear Rock No. 1 Dam
STATE LOCATED: Pennsylvania
COUNTY LOCATED: Cambria
STREAM: Bear Rock Run
SIZE CLASSIFICATION: Small
HAZARD CLASSIFICATION: High
OWNER: Highland Sewer and Water Authority
DATE OF INSPECTION: November 13 and December 28, 1979

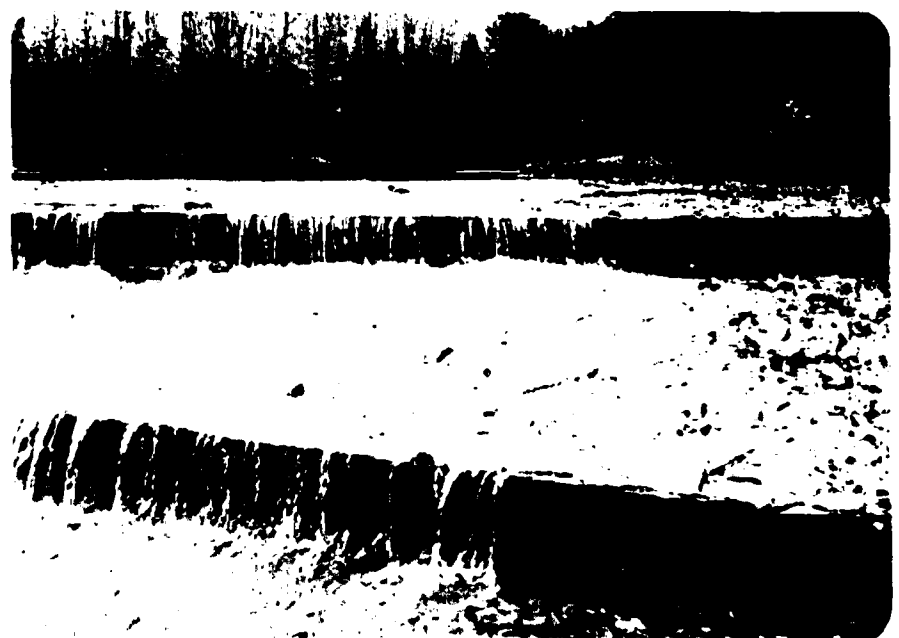
Photograph No. 2
Spillway crest.

VISUAL EXAMINATION OF	OBSERVATIONS	REMARKS OR RECOMMENDATIONS
CONCRETE WEIR	In good condition.	
APPROACH CHANNEL	Submerged. Appears to be free of debris.	
DISCHARGE CHANNEL	Earth channel in good condition.	
BRIDGE AND PIERS	None
